# Appendix E

## Testing Program

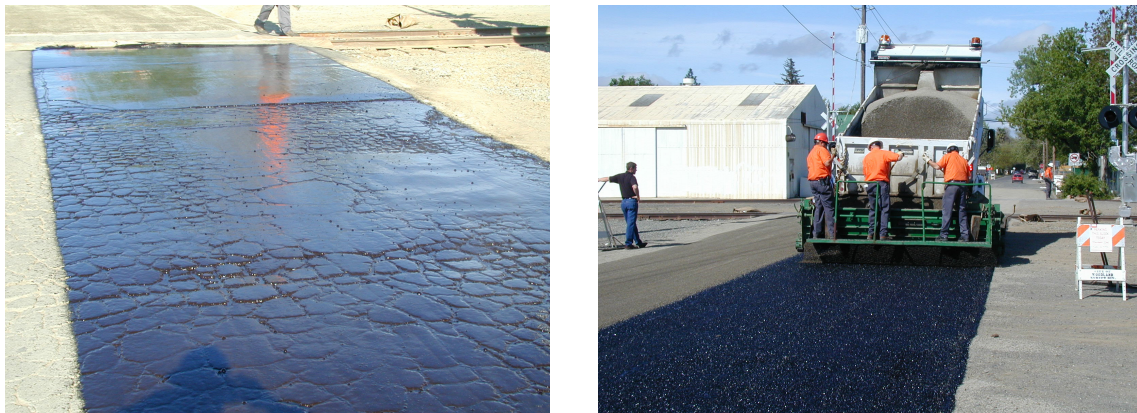
**Figure 12: Left - PASS® emulsion penetrating the cracked original surface.  
Right - Application of the second layer of the double chip seal.**

Currently this block of pavement shows some reflective cracking, however it appears that the base material remains structurally sound. The current condition of the road is better than was expected based upon the amount of truck traffic, the original condition of the road and the minimal repairs completed before the surface treatment was completed.

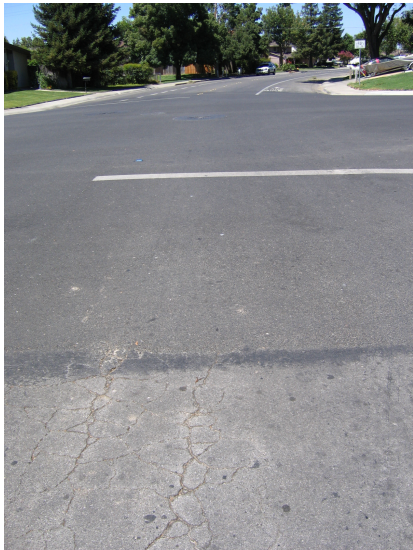
**Figure 14:** Overlay on El Dorado is doing well controlling the reflective cracks.

Currently, the pavement condition of the test areas is very good. The most notable distress is minor oxidation which is an age related distress and not directly related to the materials used.

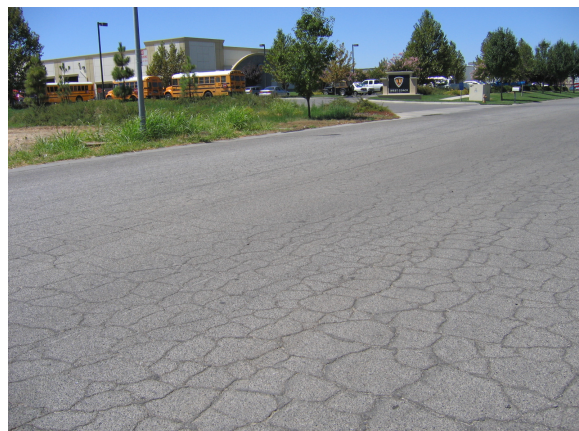
The current condition of Santa Anita after two years of service is worse than was expected. There are significant cracked areas and reflective cracking. This may be due in part to the amount of trucks and busses traveling over this section on a daily basis. However it is a definite contrast to the Oak Avenue PASS® double chip seal which was completed two years earlier and is in better overall condition.

**Figure 15:** The severely cracked condition of Santa Anita is not what was expected.
