**ADVANCED (LEVEL 3) RISK ASSESSMENT:
VALLEY OAK
CASA LINDA DRIVE, WOODLAND, CALIFORNIA**

**Prepared for
THE CITY OF WOODLAND**

**Prepared by
TREE ASSOCIATES, INC.**

August 13, 2021

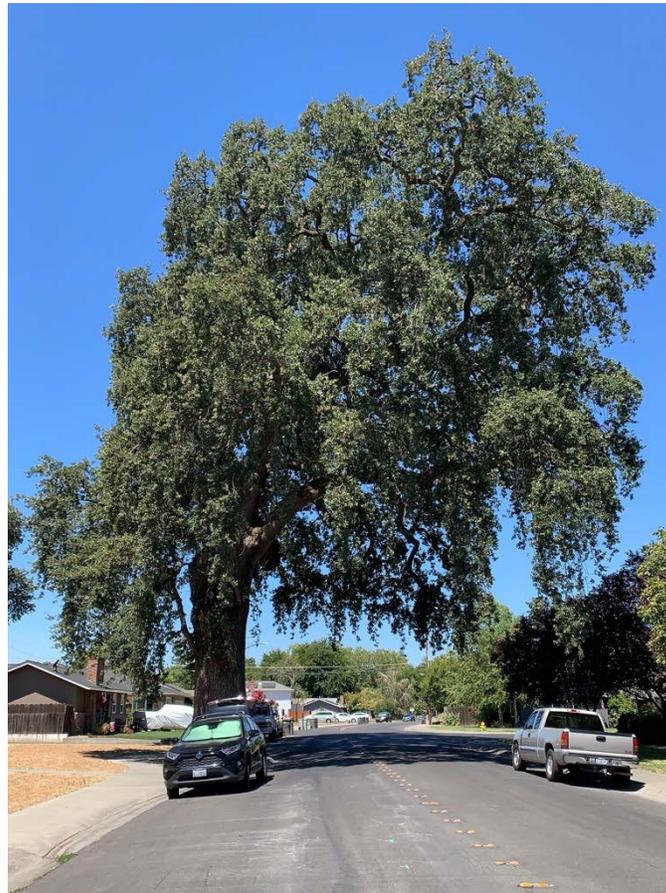
Considering the tree's vigor, canopy density, leaf size and color, I rated the overall health of the tree as good (Figure 2). I rate the health and structure of a tree separately. This is because healthy trees can be structurally unsound and unhealthy trees may be structurally sound.

Figure 2. Looking westward at subject tree from Casa Linda Drive.

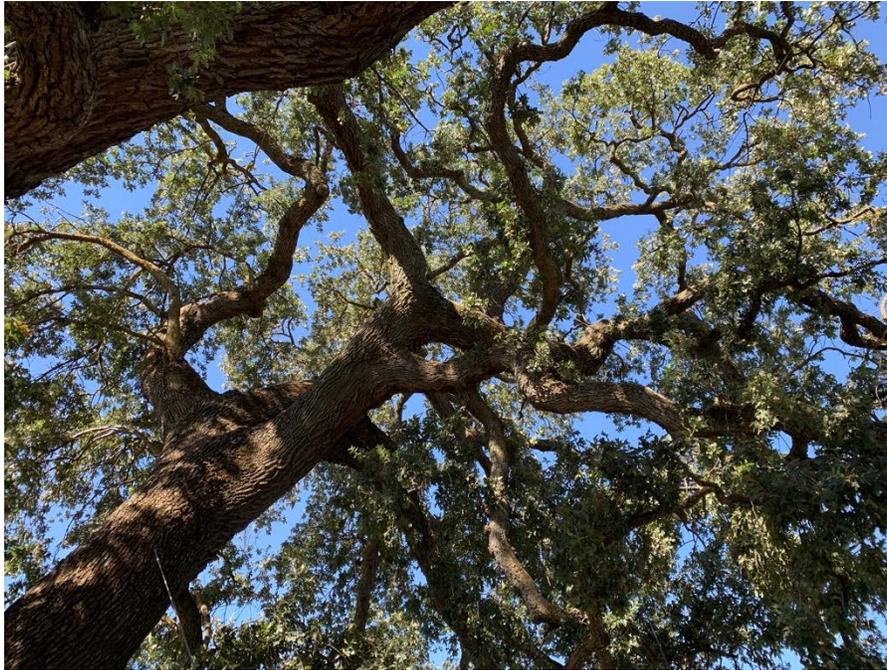
- North facing primary limb attached at 25 feet above grade.
- Northeast facing primary limb attached at 37 feet above grade.
- South facing primary limb attached at 25 feet above grade (failed limb).
- Southeast facing primary limb attached at 34 feet above grade (failed limb).
- West facing primary limb attached at 28 feet above grade.
- Main trunk divides into three secondary trunks at 49 feet (Figure 3).

Figure 3. View of secondary trunks, attached at 49 feet above grade.

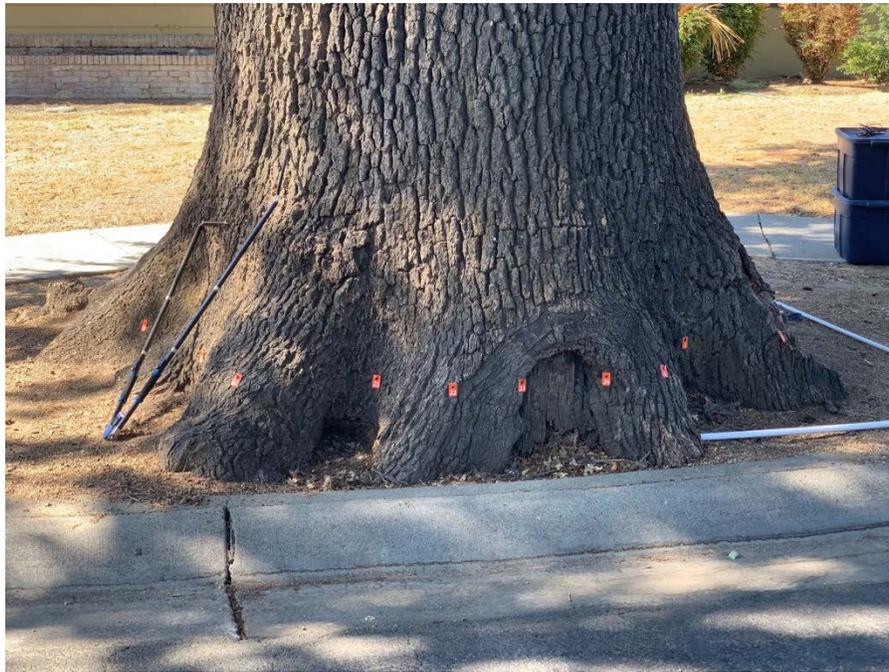
- The north base of the trunk and roots were against the street curb.
- A very large root was cut many years ago adjacent to the north side of the trunk. I'm guessing this was done to install the curb and gutter when the subdivision was developed in the 1950's. The wound created was within the trunk wood and was 15 inches wide by 18 inches tall (Figure 4). I was able to insert a metal probe nine inches into the face of the wound.

- A cavity opening (5 inches wide by 3 inches tall) was present at the base of the north-northeast side of the trunk (Figure 4).
- A basal cavity opening was present on the west side of the trunk with an opening of 5 inches wide by 2 inches tall. I was able to insert a metal probe 24 inches into the trunk at that location (Figure 5).

Figure 4. Looking southward at base of trunk. Note large old cut of major structural root on north side of trunk between tags 23 and 24. Tags are measuring points from lower trunk scan (discussed below). Another cavity opening was present at the base of the trunk near measuring point 21.

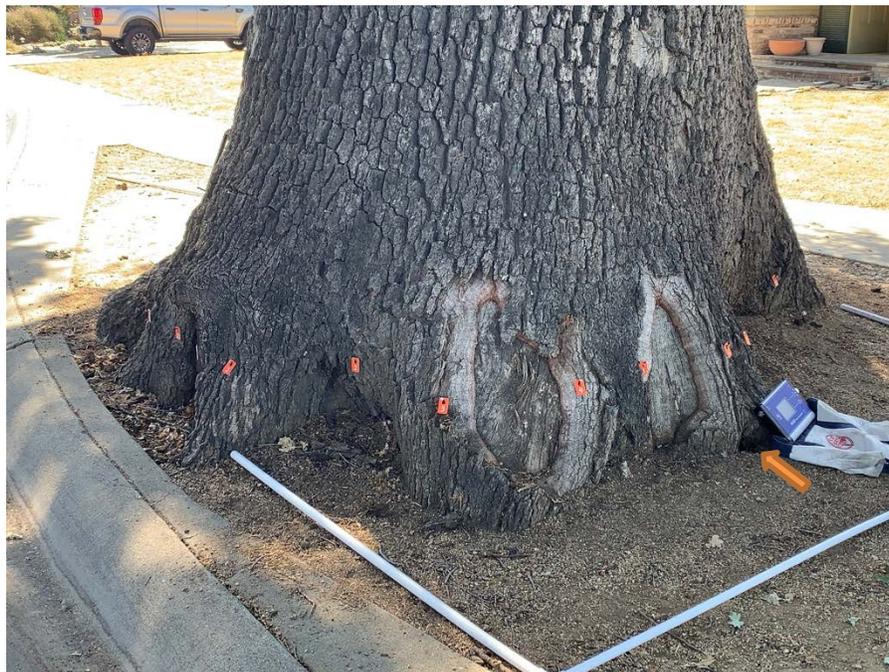
Figure 5. Looking southwestward at trunk base. Note large wounds between tags 3-4 and 5-6. A cavity opening into which I inserted a probe 24 inches was located under tag 6, adjacent to the sonic tomograph field computer (arrow).

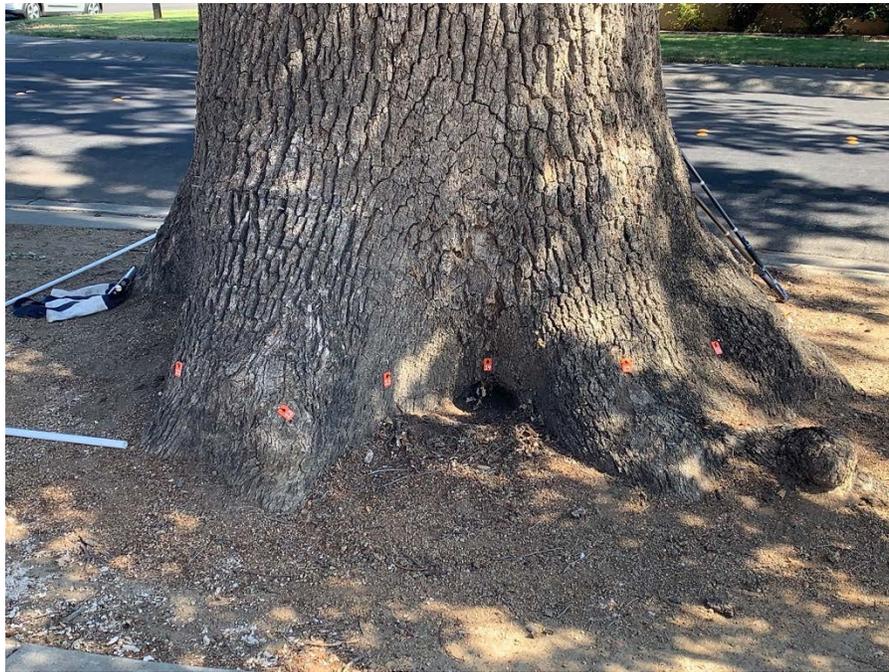
- A cavity opening was visible at the base of the south-southeast side of the trunk. The opening was 5 inches wide by 2 inches tall. I was able to insert a probe 12 inches into this opening (Figure 6).

Figure 6. Looking north northwestward at trunk base. Note cavity opening below tag 14.

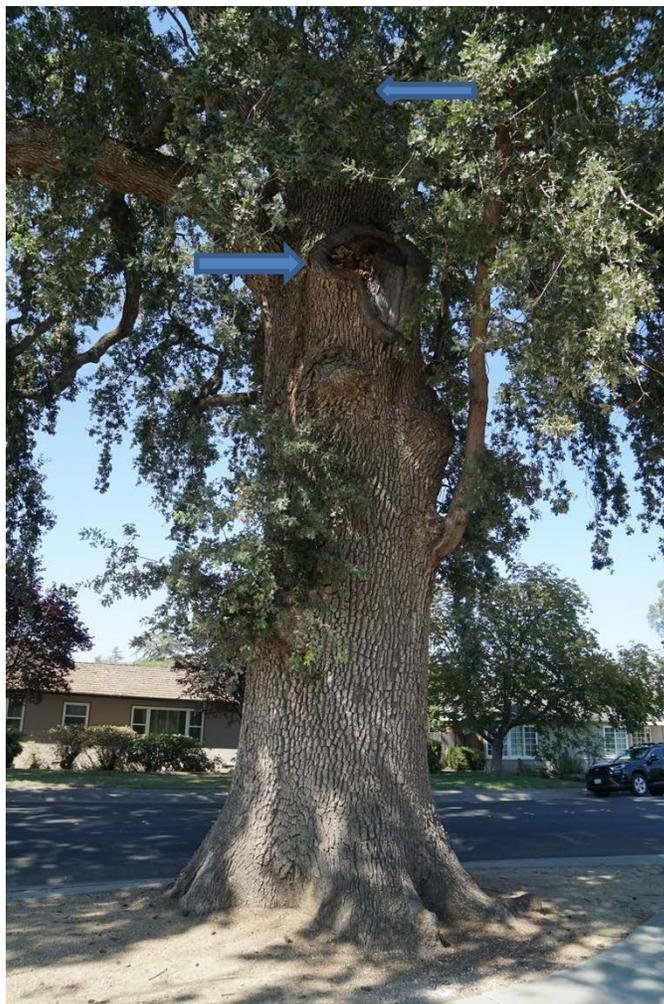
- A very large, south facing primary attached at 25 feet previously failed and its stub was removed. The maximum size of the cut was 6 feet tall by 3.5 feet wide. Remnants of the fruiting bodies of a decay fungus (likely *Laetiporus sulfureus*) were visible on cut surface (Figures 7,8).

- A very large southeast facing primary limb attached at 34 feet failed and the stub was removed (Figures 7,9).
- The west facing primary limb attached at 28 feet was previously shortened with a 15-inch diameter reduction cut.²

Figure 7. Looking north northeastward at trunk. South primary limb at 25 and southeast facing primary limb at 37 feet (hidden, see Figure 9) shown with arrows.

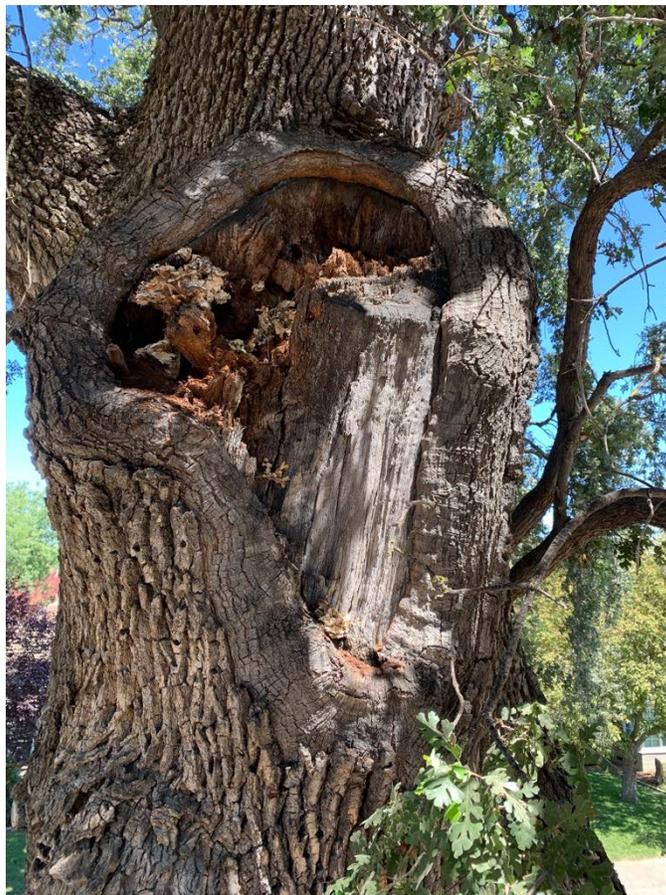
The results of the drill testing adjacent to and below the attachment of the failed primary limbs revealed the presence of decay within the failed primary limb tissue within the trunk. There was between three inches and 8 inches of sound wood adjacent to and below the attachment of the failed south facing primary attached at 25 feet.

Figure 8. Detail of failed south facing primary limb at 25 feet above grade. Note remnants of decay-fungus fruiting bodies or conks (arrows).

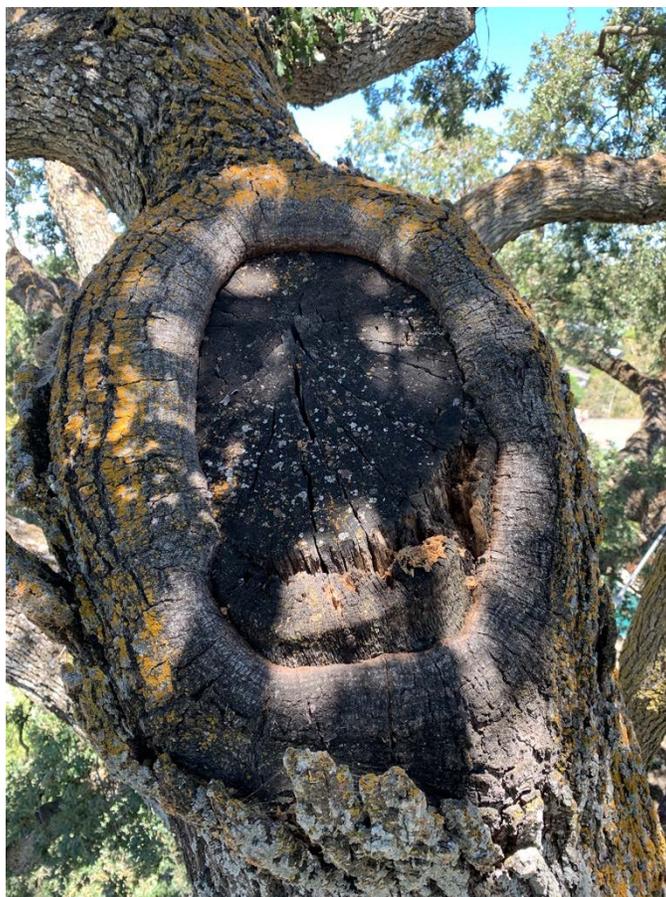
Adjacent to and below the failed southeast facing primary limb attached at 34 feet I found between 3.75 and 6 inches of sound wood. I detected no decay and found > 7 inches of sound wood on the east, north and west sides of the trunk near the height of the failed primary limbs.

Figure 9. Detail of failed southeast facing primary limb failure attachment at 34 feet.

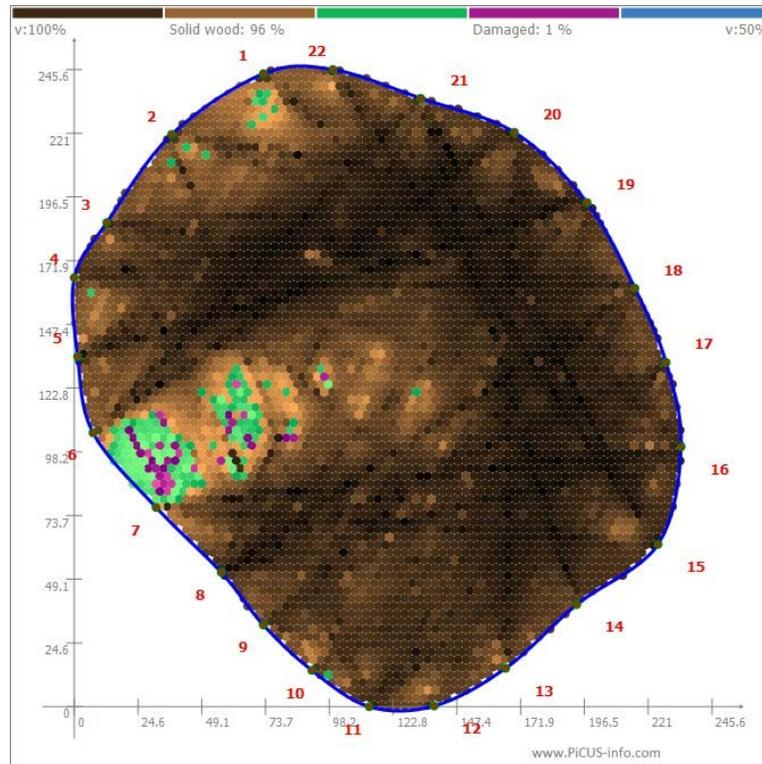
The tomogram from the scan at 30 inches above grade indicated that 96% of the wood at that level of the trunk was solid.

Figure 13. Tomogram from scan of subject tree trunk at 30 inches above grade. Measuring points (MP's) indicated with red numbers; MP 1 is on the north side of the trunk.

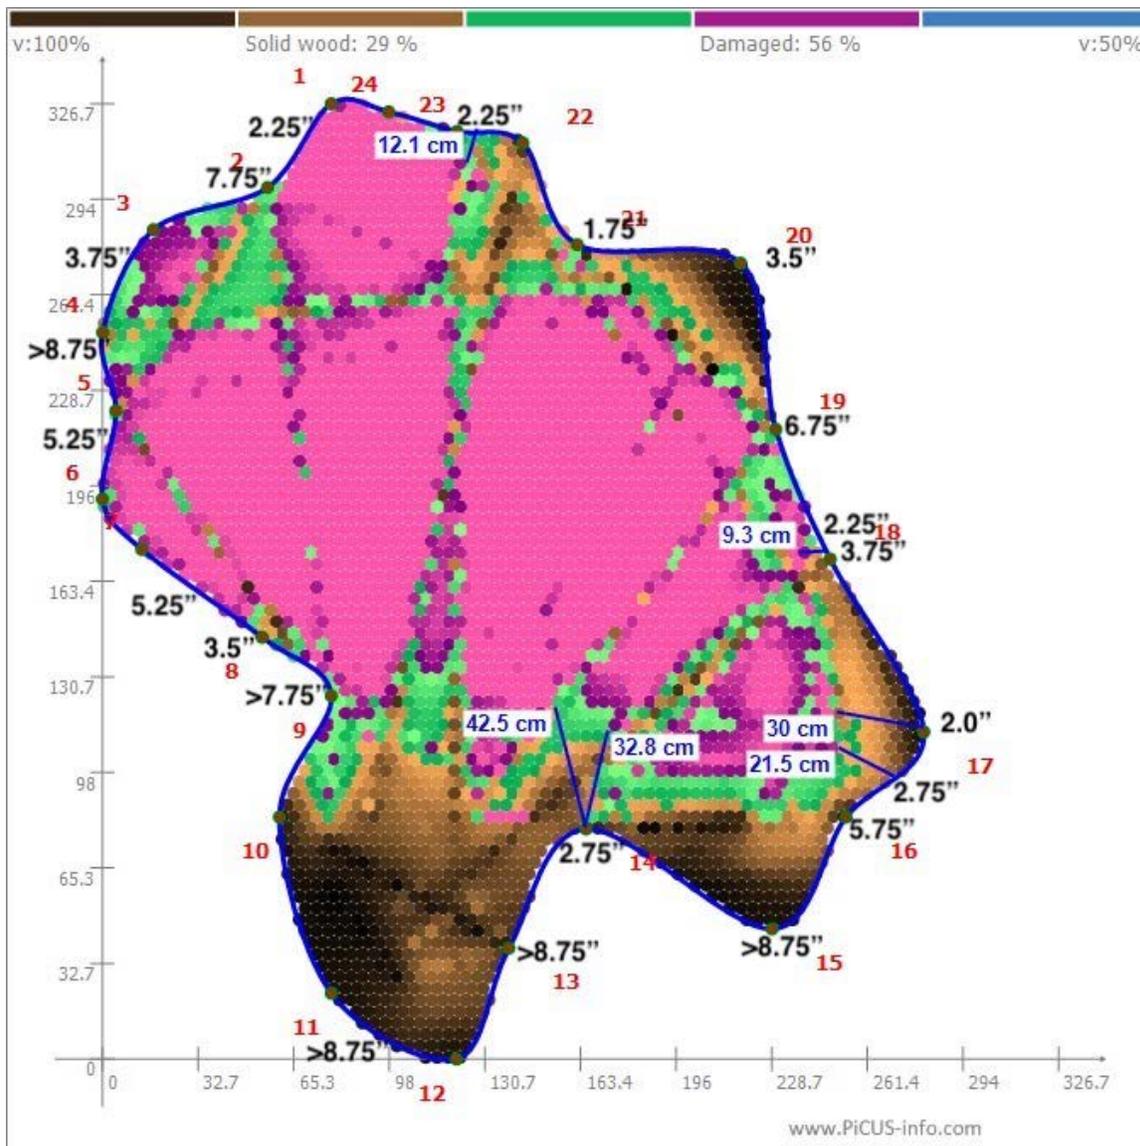
The tomogram from the scan at 12 inches above grade, in contrast, indicated that only 29% of the wood at that level was solid (Figure 14). The tomogram revealed that there was essentially no sound wood on portions of the north, west and east sides of the trunk.

Some representative distances between the outside of the wood to the damaged or missing wood as shown by the tomogram are shown in blue in centimeters. The black numbers refer to drill testing results, covered in the next section of the report.

It should be noted that trunk decay usually moves into the tree from below ground and in the vast majority of cases is more pronounced near the base of the tree. Therefore, it is not surprising that the lower scan indicated more damaged wood than the higher scan.

Figure 14. Tomogram from scan of subject tree trunk at 12 inches above grade. Measuring points (MP's) indicated with red numbers; MP 1 is on the north side of the trunk. The black numbers refer to sound wood depths determined by resistance drill testing.

Due to the extent of trunk decay, the likelihood of trunk failure and lack of adequate risk mitigation strategies, I recommend that this tree be removed.
