**ADVANCED (LEVEL 3) RISK ASSESSMENT:
VALLEY OAK
CASA LINDA DRIVE, WOODLAND, CALIFORNIA**

**Prepared for
THE CITY OF WOODLAND**

**Prepared by
TREE ASSOCIATES, INC.**

August 13, 2021

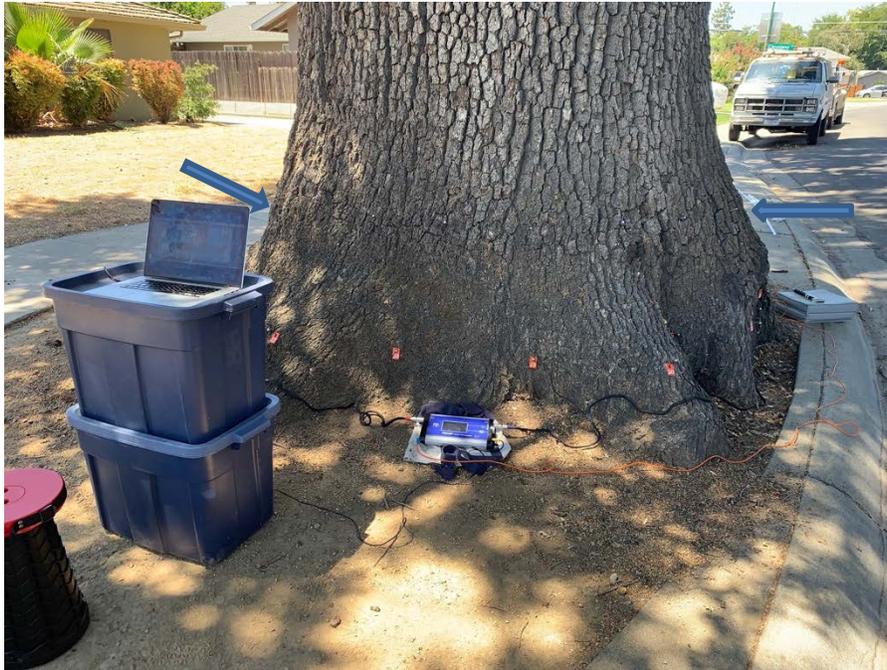
I scanned the low trunk at two elevations. The first scan, conducted on July 7, 2021 was taken at approximately 30 inches above grade. The second scan was conducted on July 16, 2021 at approximately 12 inches above grade (Figure 12).

Figure 12. Sonic tomography setup for scan at 12 inches above grade (at height of tags). Sensors are on the other side of the tree (they are moved during the scan). The scan height at 30 inches above grade is shown with arrows.
